Supplement to the Newsletter of the Friends of Pukekura Park, May 2007

Pukekura Tea House Refurbishment

Jenny Goddard, Architect

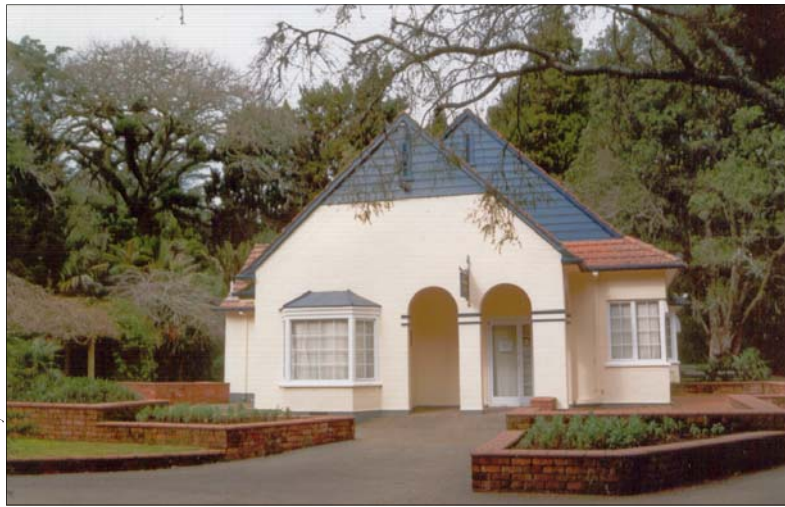
The Tea House in August 2005, before refurbishment
